Stage 1

Preliminary Site Investigation

3561 Gislason Avenue, Phase 6A, Coquitlam, BC

Submitted to:
CITY OF COQUITLAM

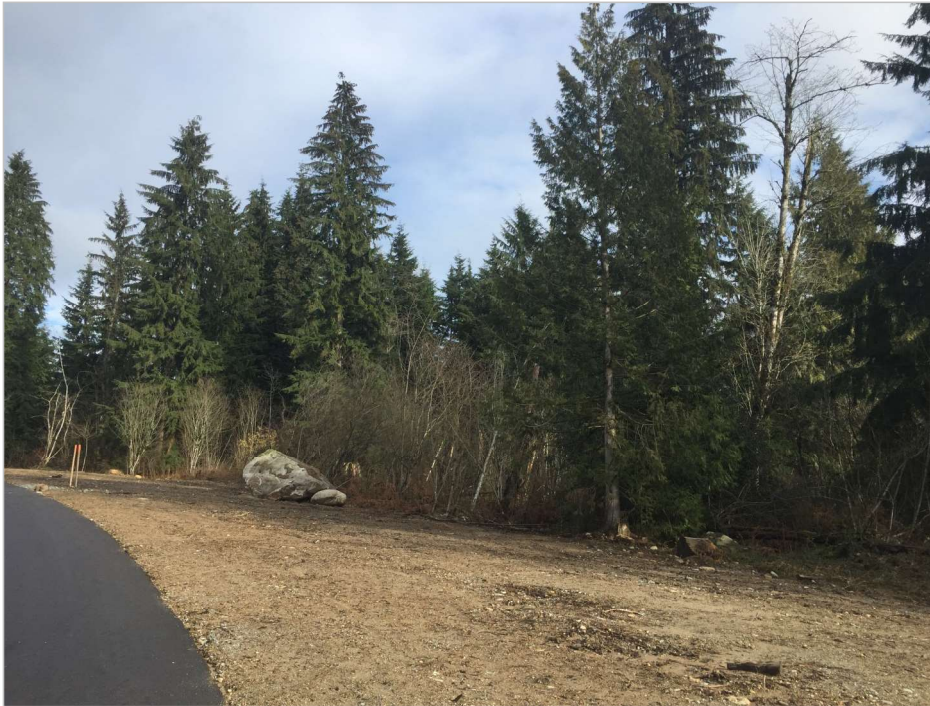
Photograph 1

Front view of Site taken from the southern Site boundary facing north.

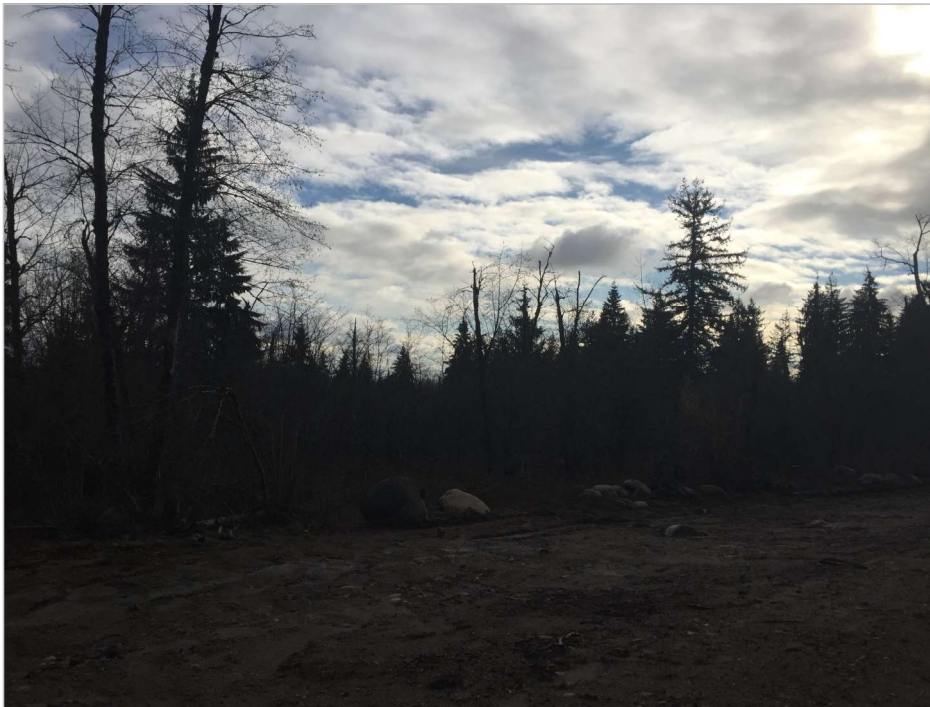
Photograph 2

Rear view of the Site taken from the north end of the Site facing south.

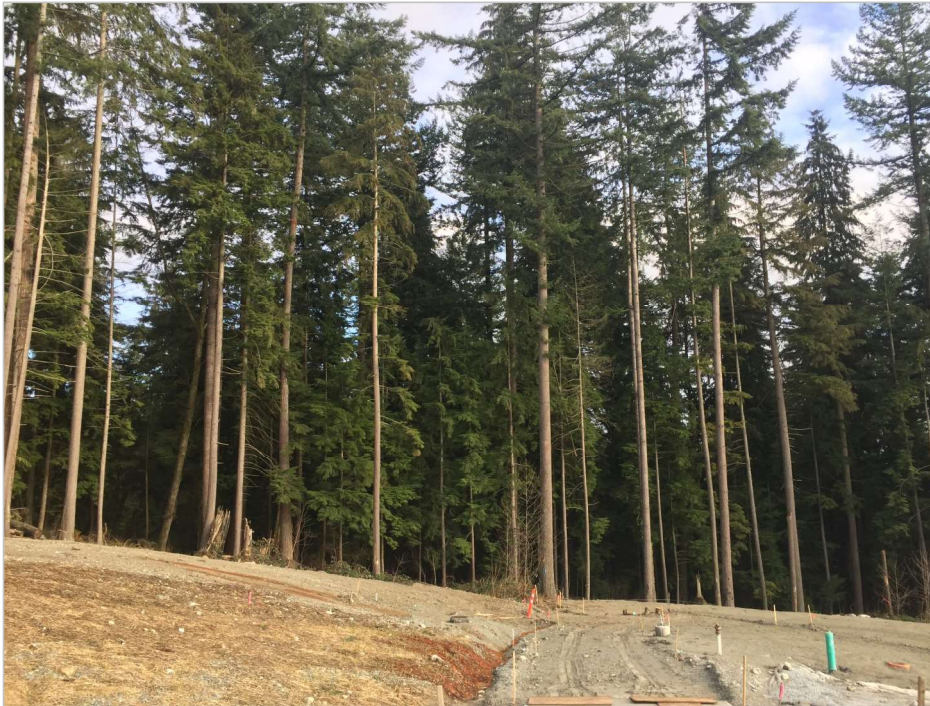
Photograph 3

View of the wildlands to the east of the Site.

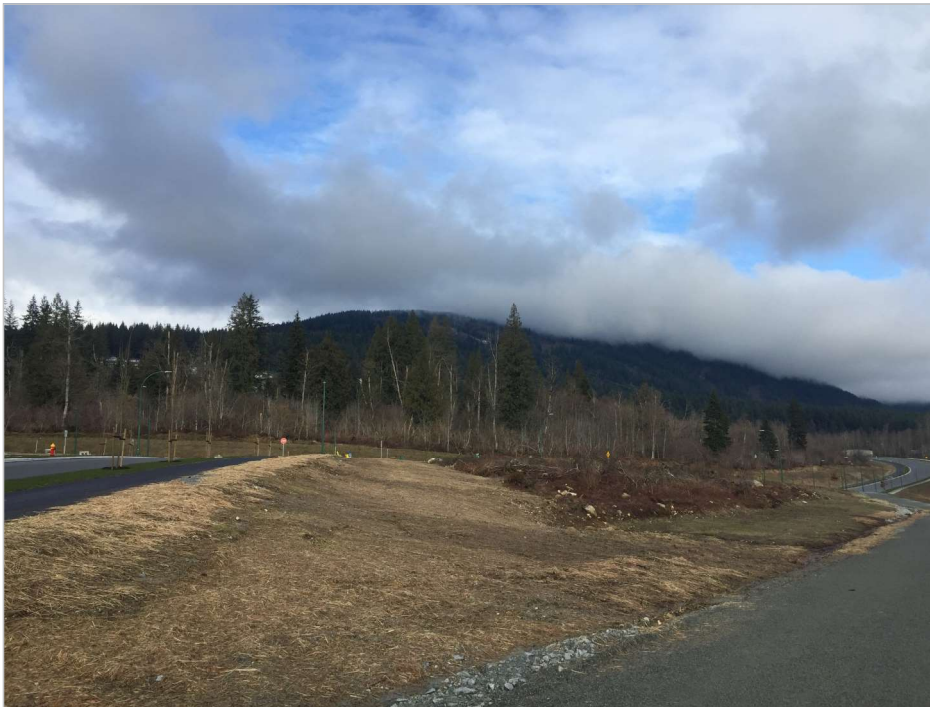
Photograph 4

View of the wildlands areas under development to the north of the Site.

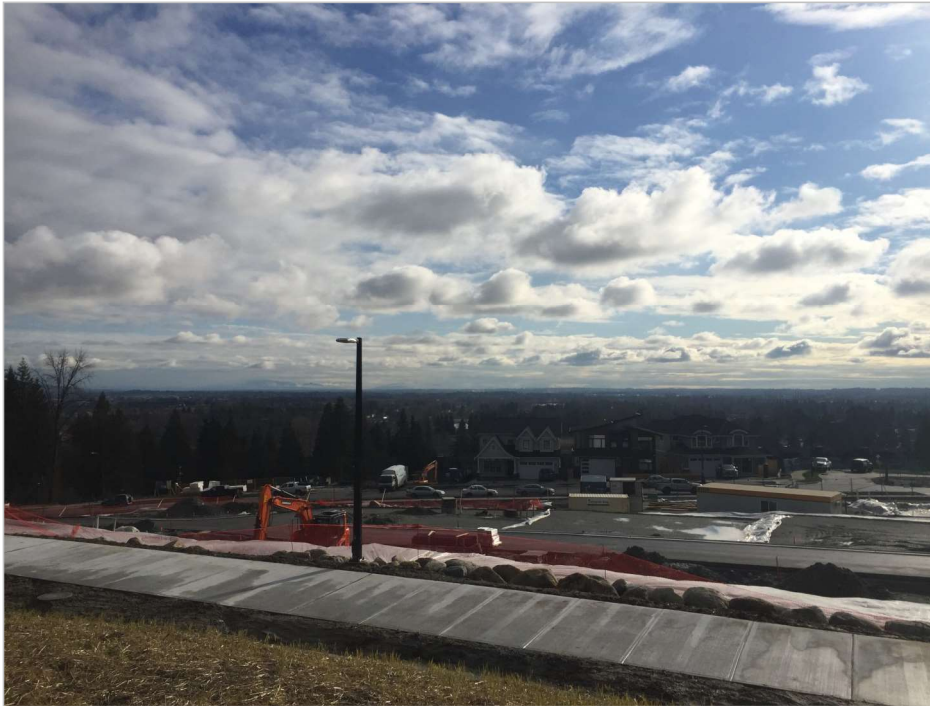
Photograph 5

View of the vacant, undeveloped area followed by cleared wildlands to the south of the Site.

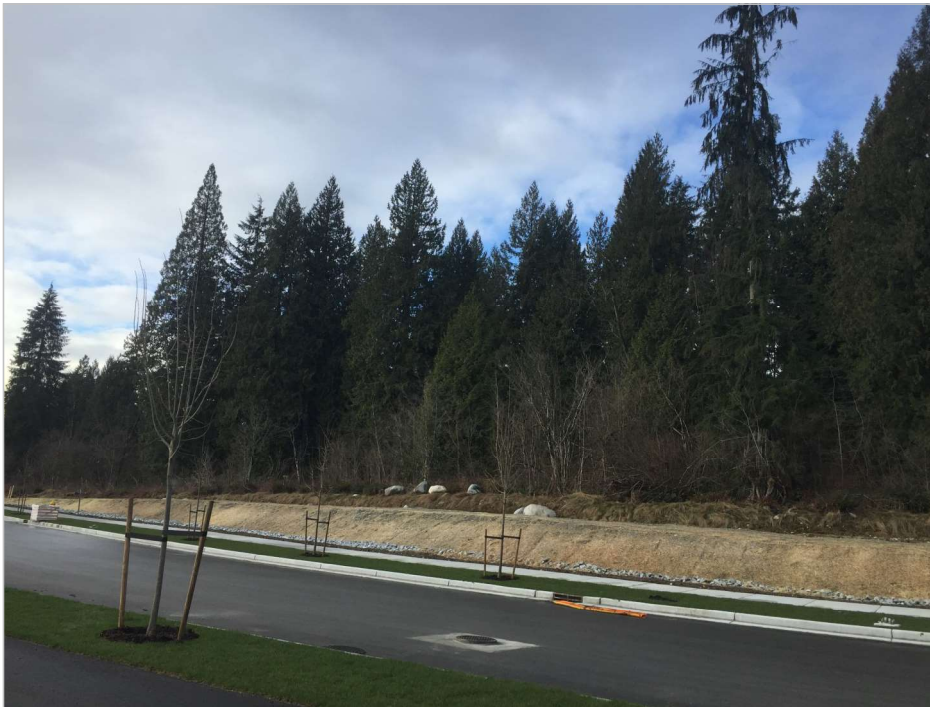
Photograph 6

View from the western Site boundary facing west towards the unnamed road and wildlands area.
